Manhole Inspection Summary

Manhole # S57Q__003MH

Insp Date: **7/7/08 10:51 AM**

Location Address: **1413 haven st.**

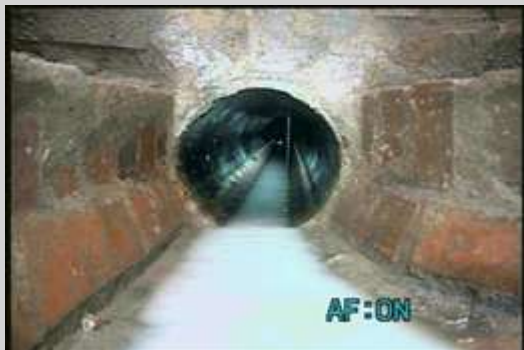
12 O'Clock Outflow

8 in. Circular Gravity Sewer
Pipe Out @ 12 O'Clock

Pipe Material: **Clay** ☐ Pipe Lined

Invert Depth: **10.72** (ft.) Flow Characteristics: **Fast**

Deposits: ☒ None ☐ Mud ☐ Sludge ☐ Debris ☐ Grease

Infiltration: **None** Pipe Seal Cond: **Unknown**

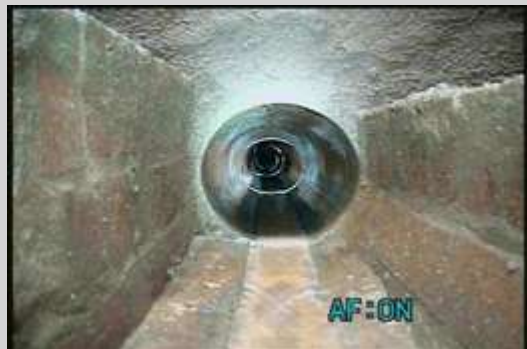
6 O'Clock Inflow

8 in. Circular Gravity Sewer

Pipe In @ 6 O'Clock

Pipe Material: **Clay** ☐ Pipe Lined

Infiltration: **None** Pipe Seal Cond: **Unknown**
